Manhole Inspection Summary

Manhole # S33MM_010MH

Insp Date: **11/28/06 2:25 PM**

Location Address: **2100 21ST ST**

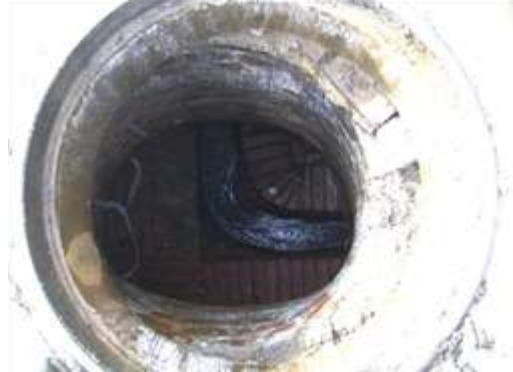
Top View

Frame offset. Adjustment deterioration, loose brick and infiltration. Corroded and missing steps. Evidence of surcharge -

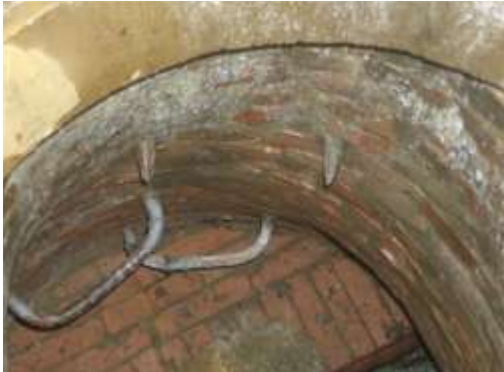
Defect

Frame leaks. Adjustment deterioration and infiltration.

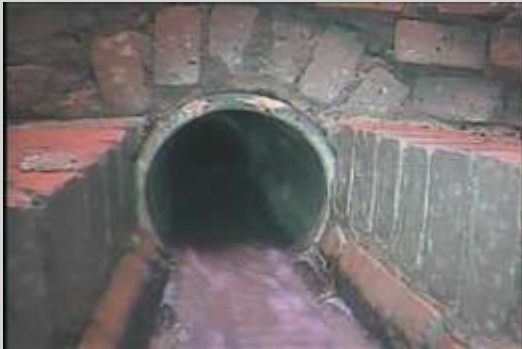
8 in. Circular Gravity Sewer Pipe Out @ 12 O'Clock

Infiltration: **Evidence** Pipe Seal Cond: **Unknown**
